imbio

RV/LV

This user manual was written for the Imbio CT RV/LV Software.

IMBIO CT RV/LV USER MANUAL

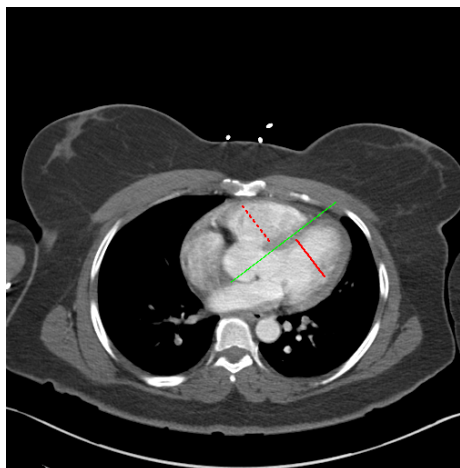
Figure 2: Example RV/LV Summary Report

RV/LV Ratio: 1.25
RV Diameter: 49.98 mm
LV Diameter: 39.87 mm

Largest Right Ventricle Diameter Located on Slice 143

Largest Left Ventricle Diameter Located on Slice 153

The RV/LV Summary Report is a DICOM compatible format file containing results from the RV/LV Software. The SOP Class of the report is either Secondary Capture or Encapsulated PDF Storage. The report summarizes the results of the RV/LV Analysis. It contains patient information, images showing the slices with the maximum ventricular diameters, the RV/LV Ratio, and the individual ventricular measurements if available. An example report is shown below in Figure 2. Note the maximum diameters of the right and left ventricle are determined independently and may occur on different slices.

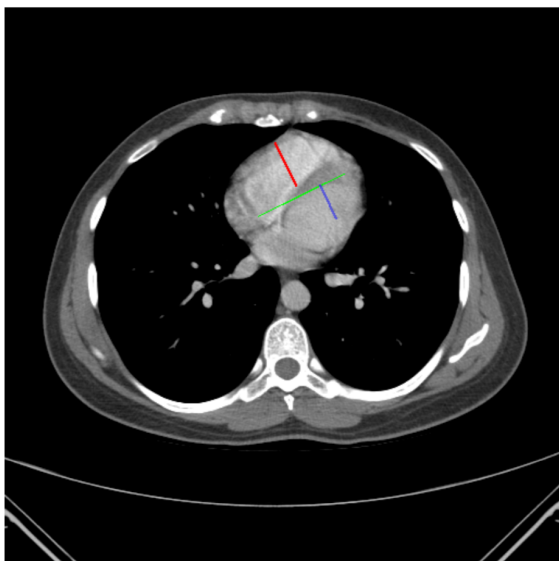
Figure 8: The interventricular septum has been identified incorrectly, leading to a poor segmentation.

3. Poor Septum Detection: This error can be identified by viewing the RV/LV Annotated Image Series or the Report. In Figure 8 below, the interventricular septum (green line) is poorly detected. The ventricular measurements are made perpendicular to the detected septum, so a poor septum detection can impact the final ventricular measurements and ratio.
