imbio

RV/LV

v2.0.0

IMBIO CT RV/LV USER MANUAL

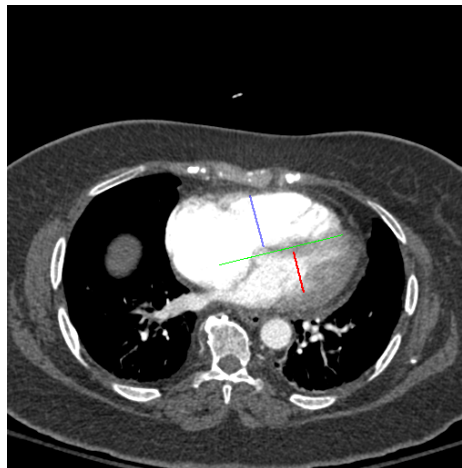
Figure 2: Example RV/LV Summary Report

The RV/LV Summary Report is a DICOM compatible format file containing results from the RV/LV Software. The SOP Class of the report is either Secondary Capture or Encapsulated PDF Storage. The report summarizes the results of the RV/LV Analysis. It contains patient information, images showing the slices with the maximum ventricular diameters, the RV/LV Ratio, and the individual ventricular measurements if available. An example report is shown below in Figure 2. Note the maximum diameters of the right and left ventricle are determined independently and may occur on different slices.

Largest Right Ventricle Diameter Located on Slice 168

Largest Left Ventricle Diameter Located on Slice 209

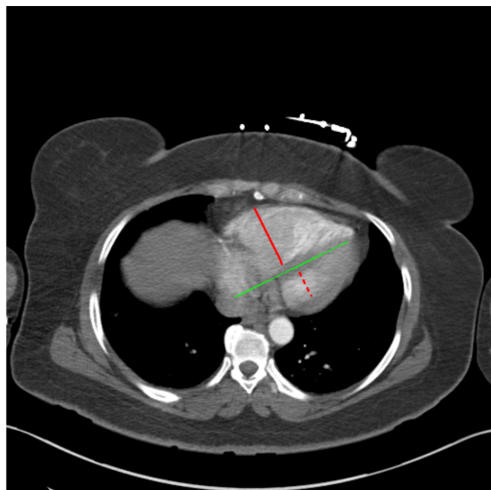
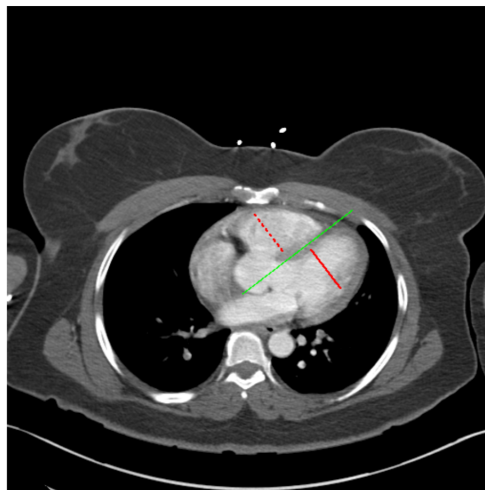
Largest Right Ventricle Diameter Located on Slice 143

Largest Left Ventricle Diameter Located on Slice 153

Figure 4: Example of ventricle images in RV/LV Summary Report. The left image displays the slice of the right ventricle with the largest diameter. The right image displays the slice of the left ventricle with the largest diameter.

The report displays two ventricle slice images from the RGB overlay. The slices selected for the report are the slices with largest ventricular diameter for the left and the right ventricle. An example of the image in the report is shown below in Figure 4.

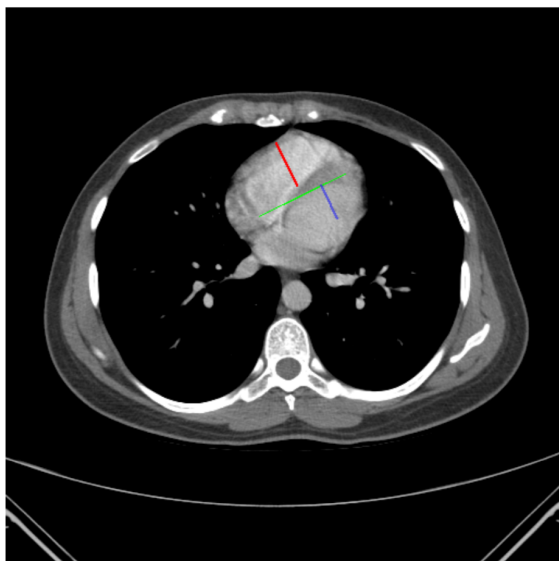
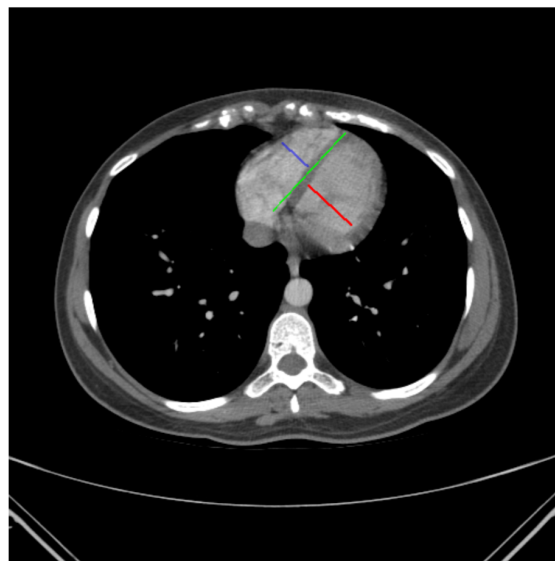
3. Poor Septum Detection: This error can be identified by viewing the RV/LV Annotated Image Series or the Report. In Figure 7 below, the interventricular septum (green line) is poorly detected. The ventricular measurements are made perpendicular to the detected septum, so a poor septum detection can impact the final ventricular measurements and ratio.

Figure 7: The interventricular septum has been identified incorrectly, leading to a poor segmentation.
